Area F: Memorial Park

AREA OF INTEREST - **F**
 VETERANS MEMORIAL PARK

The Wawayanda Creek Watershed & Water Quality

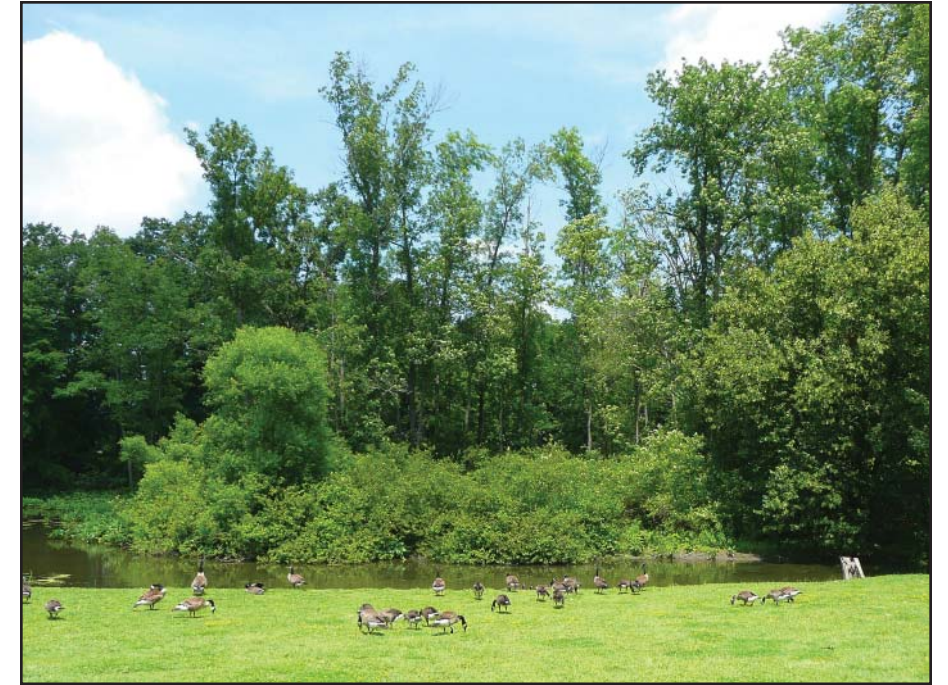
The Lake at Memorial Park Offers Opportunities for Nature Study and Could be Improved by Thick Plantings to Discourage Geese

As a Village resource, Memorial Park offers generous open space that has habitat value as well as recreational opportunities. A new boardwalk passing through native plantings at the lake (proposed in this study) will discourage geese and increase the use of Memorial Park for passive recreation: exploring, strolling, nature study, fishing, bird watching, picnicking and relaxation. Currently science classes from the Park Avenue Elementary School use the lake for environmental study. A proposed small section of boardwalk for access over wet ground and thick native plantings to discourage geese and attract a greater variety of wildlife would be of interest to these classes as well as to others who are intrigued by the natural world. The large wet field to the east before the skate park is currently kept mowed but can be restored to a wet meadow with once yearly or biennial mowing. (*See Ecologist's Report, Appendix C.*)

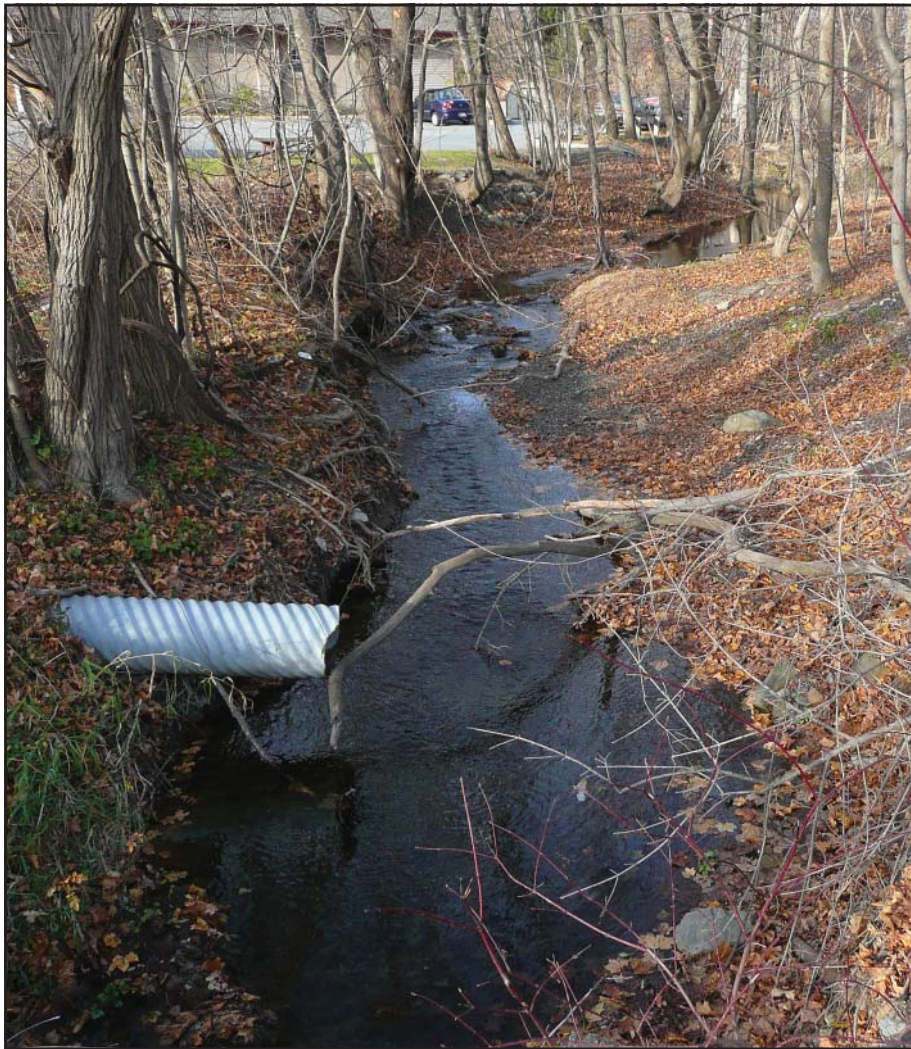
A Drainage Pipe Feeding into Witch's Brook before It Empties into the Wawayanda

The last bridge in this west to east trek is the Forester Avenue bridge. The Witch's Brook that meanders through the Village's natural area, Lewis Woodlands, enters the Wawayanda from the north, after flowing through an old culvert under the railroad right-of-way that seems barely adequate for this small stream. This area of Forester Avenue is famous for flooding and the enlarged pond area and low lying Memorial Park lands are a useful repository for high water during floods that threaten more built-up areas further downstream. From Forester Avenue, there are interesting views of the railroad bridge to the west and of the wetland area to the east in Memorial Park, where the confluence of Witch's Brook and the Wawayanda Creek is visible. A small restaurant along Forester Avenue has outdoor seating near Witch's Brook and the stream frontage could be emphasized and improved in this area.

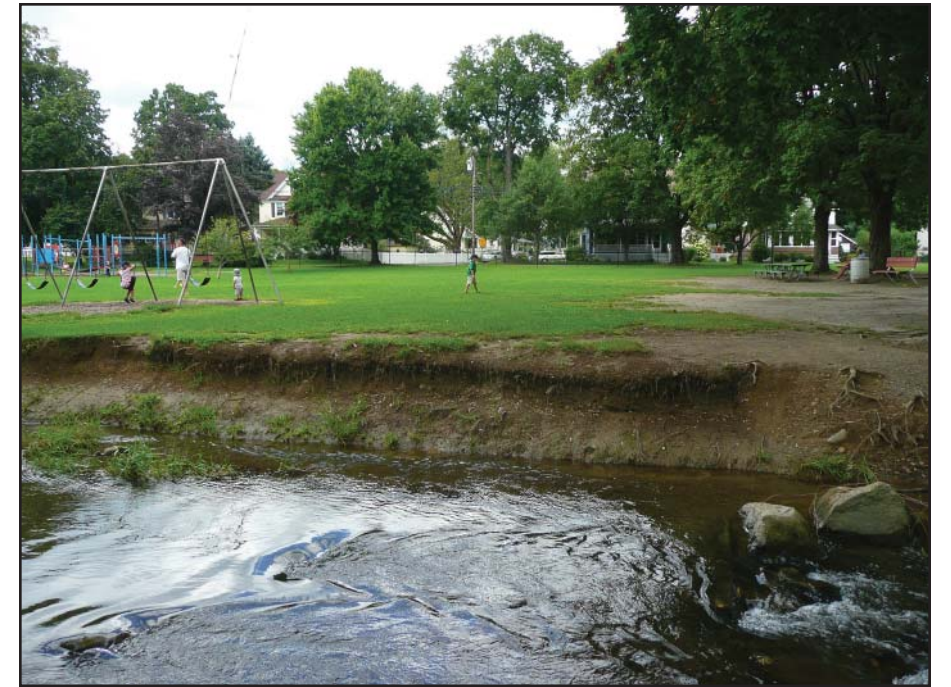
Severely Eroded Banks of the Mistucky Creek in Stanley Deming Park

initiatives related to the stream. The banks of the Mistucky in Stanley Deming Park are significantly eroded by foot traffic and the lack of stabilizing vegetation.
